13886 Clarkesville Pike, Clarkesville Howard County, Maryland

Maryland Historical Trust Maryland Inventory of Historic Properties Form

Inventory No.

HO-926

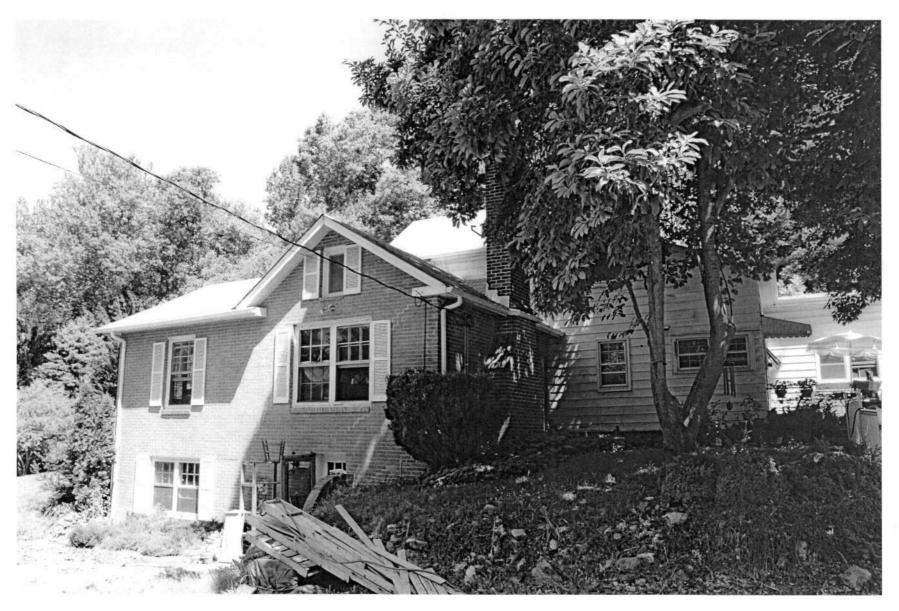
HO-926 Ken Short, June 2007 1/4

13886 Clarksville Pike South elevation

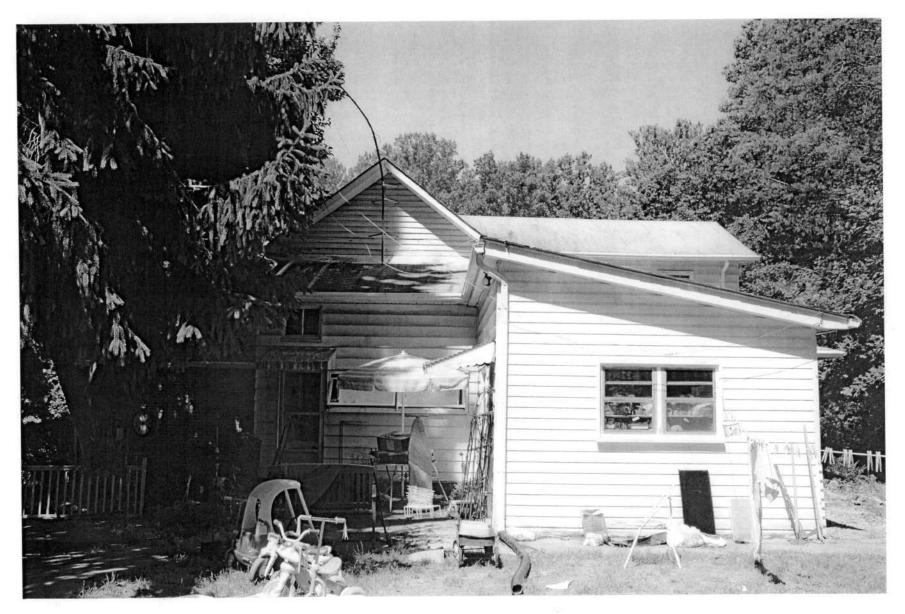
HO-926 Ken Short, June 2007 2/4

13886 Clarksville Pike East elevation

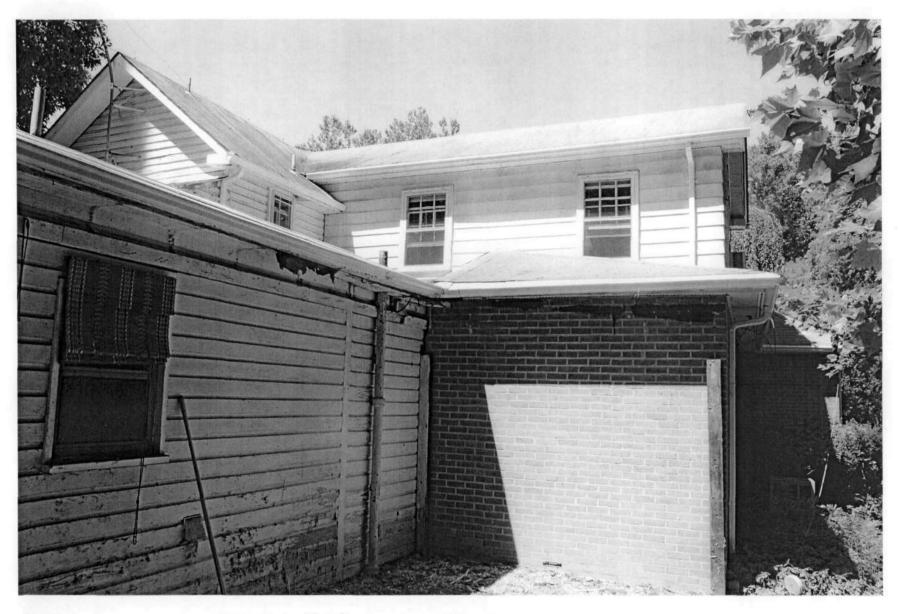
HO-926 Ken Short, June 2007 3/4

13886 Clarksville Pike East & north elevations

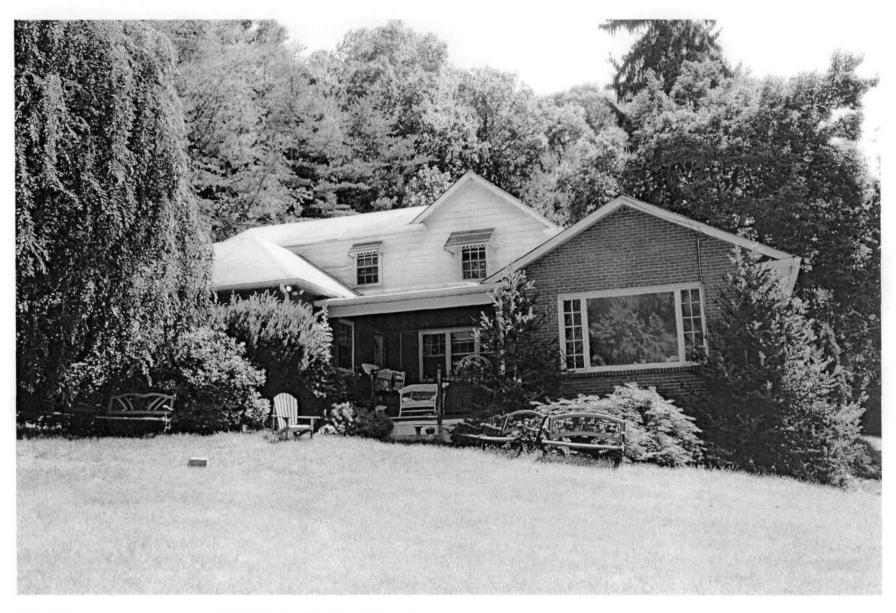
HO-926 Ken Short, June 2007 4/4

13886 Clarksville Pike West elevation
